Red Rock Home Inspections

Property Inspection Report

1234 Fake St. , Bonsall, Ca 92003
Inspection prepared for: Report Sample
Date of Inspection: 10/12/2013 Time: 2:00pm
Age of Home: 15 Size: 2200
Weather: Overcast/hot

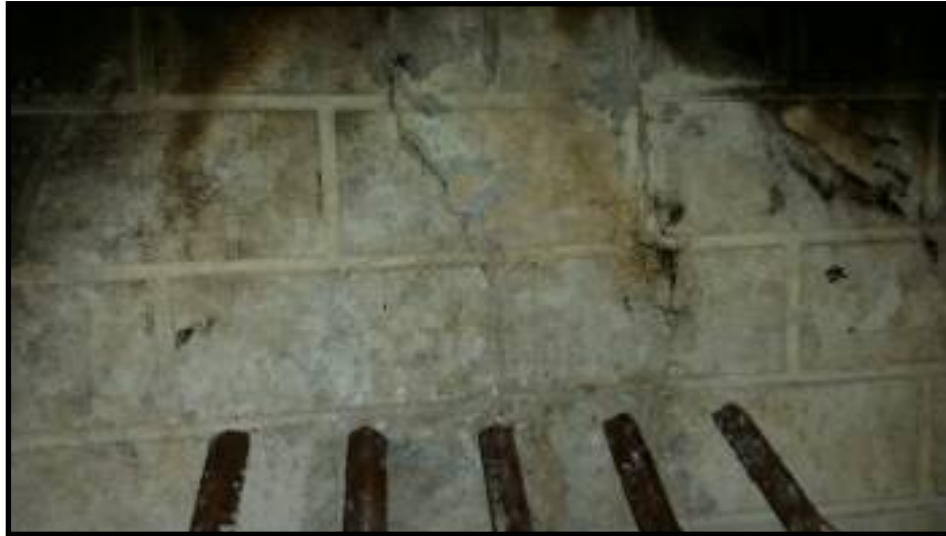
10. Fireplace

- Damper was opened and closed several times.
- **SAFETY - A large crack was observed in the firebox for the dining room fireplace. Recommend further evaluation and repair by qualified contractor prior to use.**

Interior Areas		
Page 6 Item: 10	Fireplace	• SAFETY - A large crack was observed in the firebox for the dining room fireplace. Recommend further evaluation and repair by qualified contractor prior to use.
Bedrooms		
Page 7 Item: 6	Fireplace	• A crack was observed in the back wall of the firebox in the fireplace located in the master bedroom. It appears previous attempts to repair have been made. Recommend further evaluation and repair by qualified contractor prior to use.
Bathroom		
Page 9 Item: 8	Exhaust Fan	• The bath fan in the south bathroom did not operate when tested.
Kitchen		
Page 12 Item: 3	Dishwasher	• SAFETY- Dishwasher draining through air gap and leaking under sink near electrical outlet. Possibly due to drain plug not knocked out on disposal. Recommend repairs by qualified individual.
Heat/AC		
Page 15 Item: 2	Heater Base	• PREVENTATIVE MAINTENANCE Recommend installing secondary catch pan under furnace to prevent potential damage to ceiling from condensate related to the evaporator coil for the a/c.

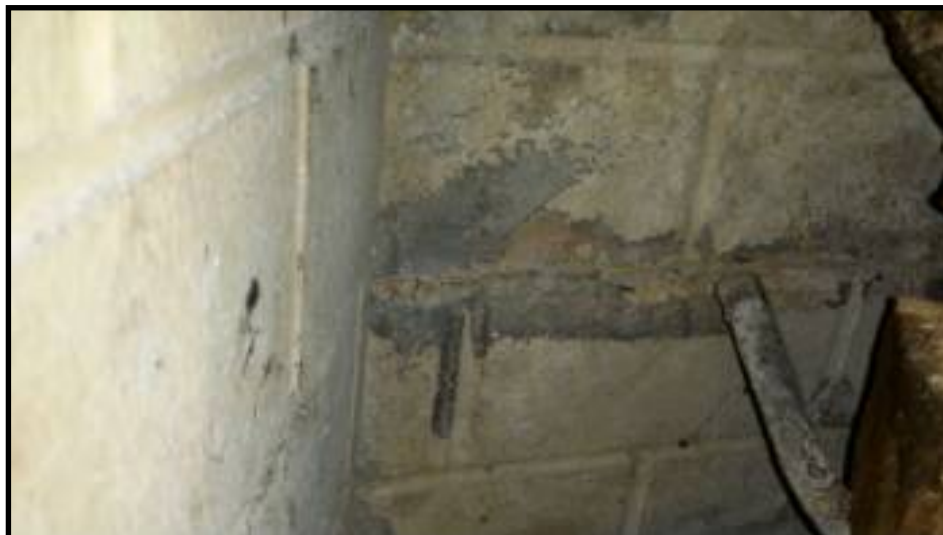
6. Fireplace

- Damper was opened and closed several times.
- A crack was observed in the back wall of the firebox in the fireplace located in the master bedroom. It appears previous attempts to repair have been made. Recommend further evaluation and repair by qualified contractor prior to use.

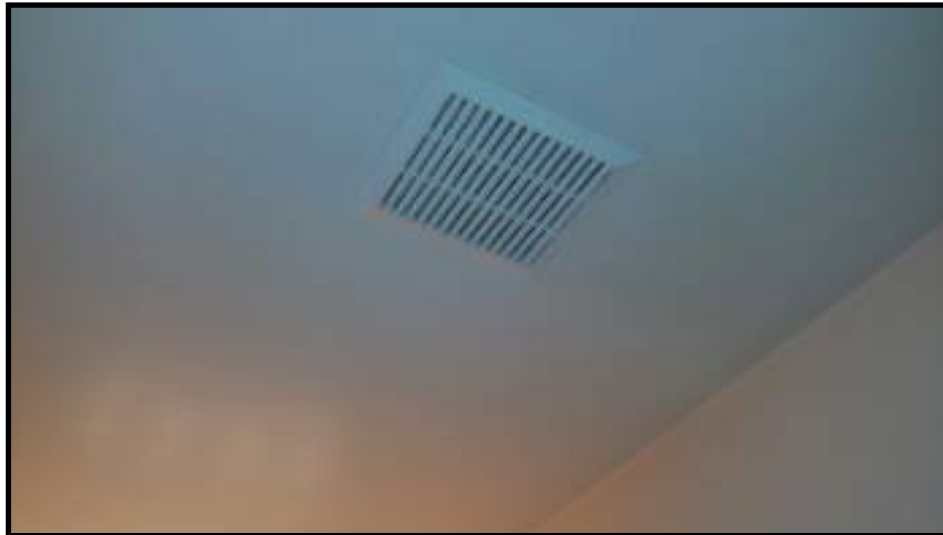
8. Exhaust Fan

Observations:
 • The bath fan in the south bathroom did not operate when tested.

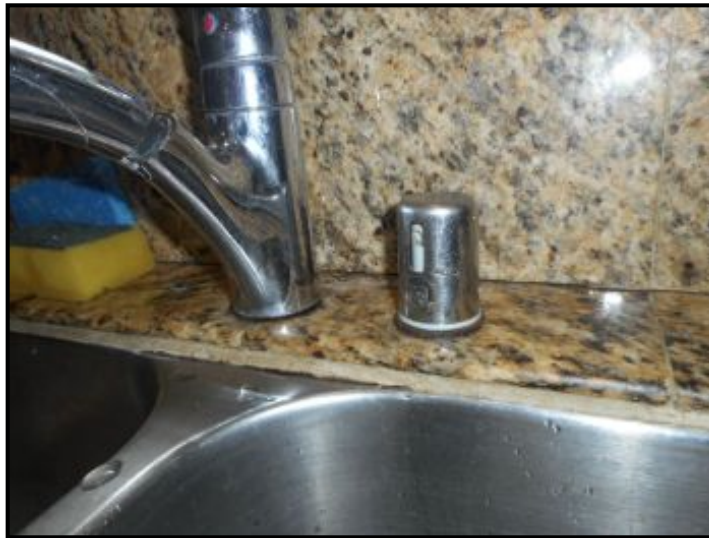
3. Dishwasher

Observations:
 • Operated.
 • **SAFETY-** Dishwasher draining through air gap and leaking under sink near electrical outlet. Possibly due to drain plug not knocked out on disposal. Recommend repairs by qualified individual.

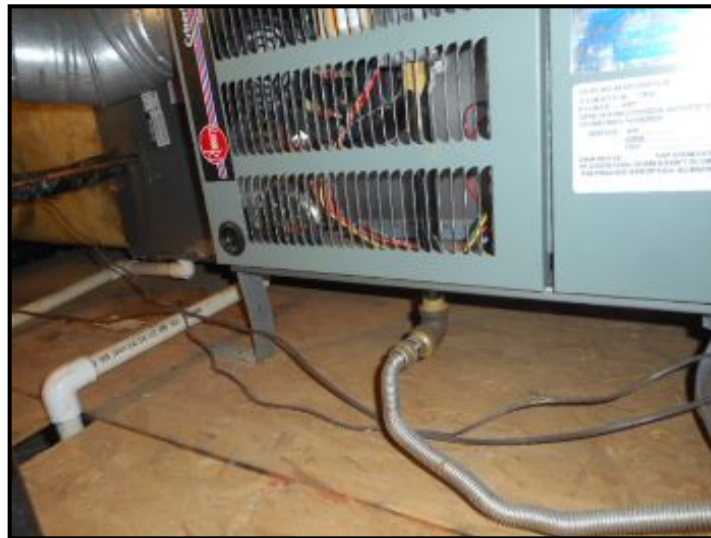
2. Heater Base

• **PREVENTATIVE MAINTENANCE** Recommend installing secondary catch pan under furnace to prevent potential damage to ceiling from condensate related to the evaporator coil for the a/c.

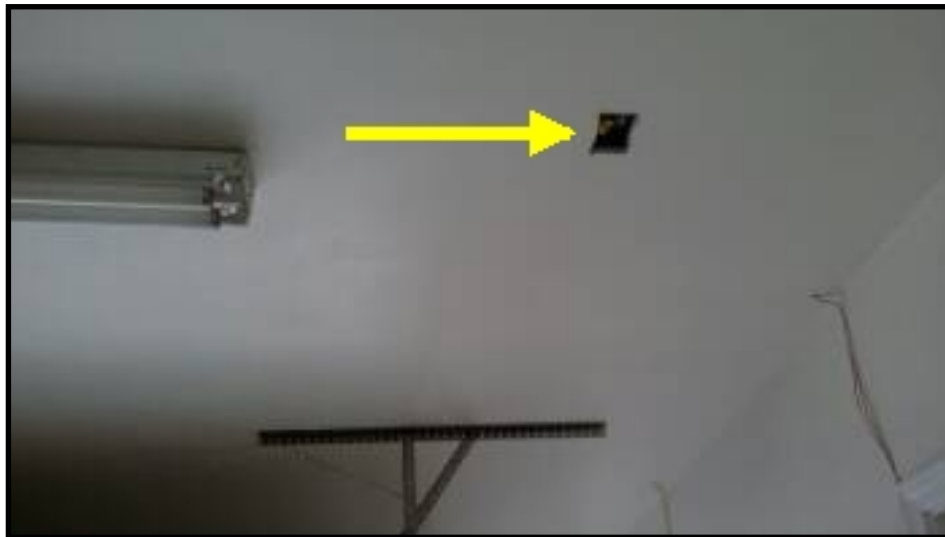
3. Electrical

Observations:
• **Missing cover plate observed, suggest installing for safety.**

Garage		
Page 18 Item: 3	Electrical	• Missing cover plate observed, suggest installing for safety.
Page 18 Item: 5	Exterior Door	• Minor damaged observed at base of exterior garage door jamb. Recommend repairing and painting to prevent further deterioration.
Page 19 Item: 6	Fire Door	• The automatic closure device does not close the door properly. This could allow a fire to enter the home. Recommend adjusting or replacing the hinges to allow for proper closure of the door.
Roof		
Page 22 Item: 1	Roof Condition	• A small number of tiles were observed broken during inspection. Recommend licensed roofing contractor replace affected tiles as needed.
Attic

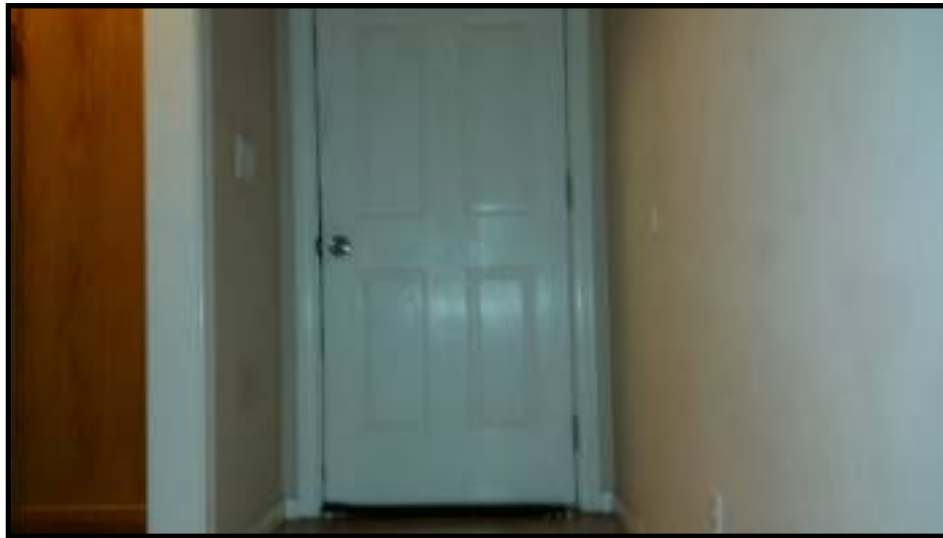
6. Fire Door

- The automatic closure device does not close the door properly. This could allow a fire to enter the home. Recommend adjusting or replacing the hinges to allow for proper closure of the door.

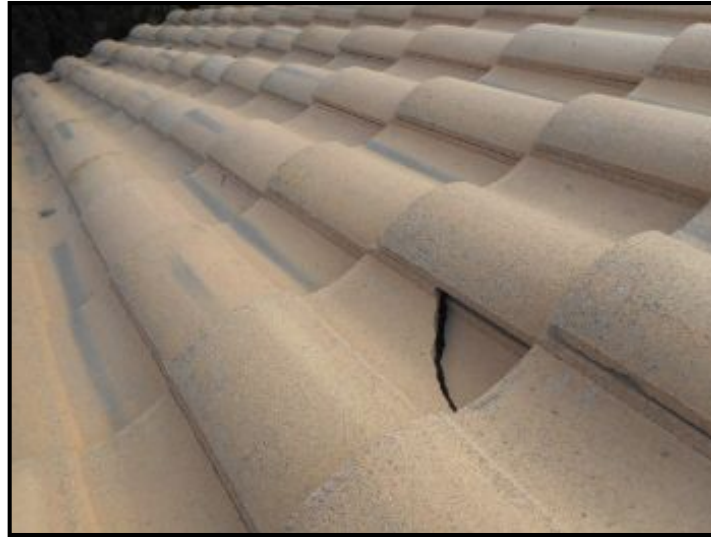
- A small number of tiles were observed broken during inspection. Recommend licensed roofing contractor replace affected tiles as needed.

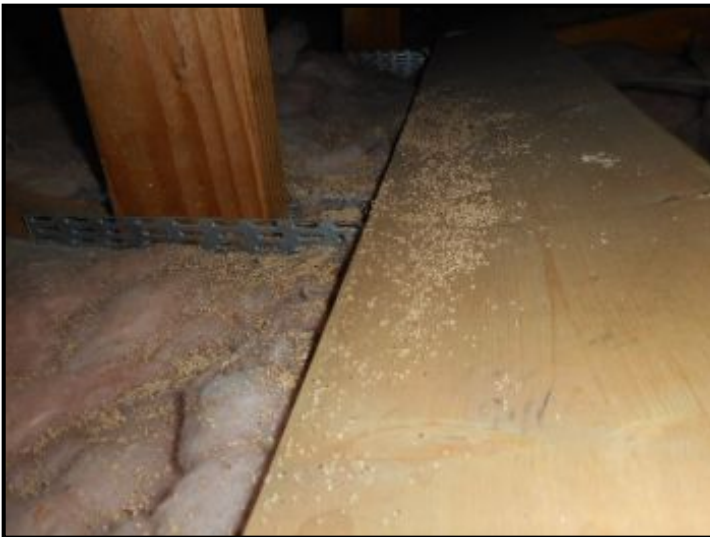
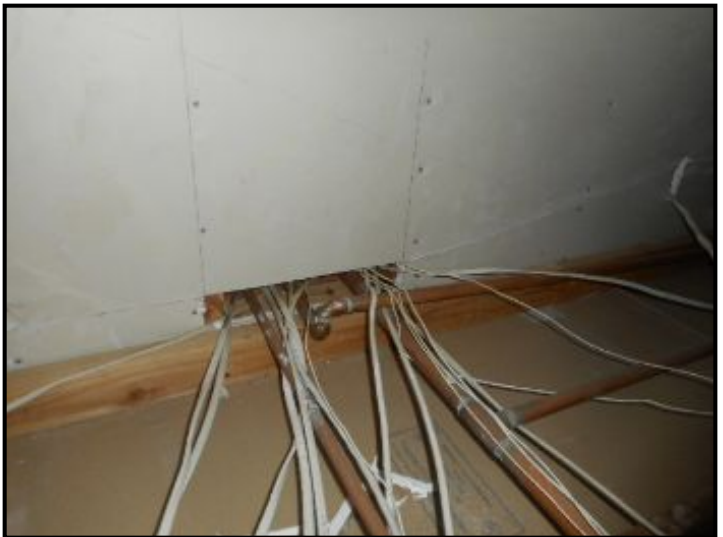
- **Evidence of possible wood destroying organisms observed in the attic. Recommend further evaluation by a licensed pest control company.**
- **SAFETY - The fire separation in the attic between the garage and the house has been compromised due to pipe and wiring penetrations. Recommend sealing void around pipes and wire with a rated fire proof material.**

Page 23 Item: 2	Structure	<ul style="list-style-type: none">• Evidence of possible wood destroying organisms observed in the attic. Recommend further evaluation by a licensed pest control company.• SAFETY - The fire separation in the attic between the garage and the house has been compromised due to pipe and wiring penetrations. Recommend sealing void around pipes and wire with a rated fire proof material.
Page 24 Item: 6	Electrical	<ul style="list-style-type: none">• I observed a power strip with a flood light in the garage attic. Recommend removing and installing a permanent switched light fixture if lighting is desired in the garage attic space.
Exterior Areas		
Page 25 Item: 6	Stucco	<ul style="list-style-type: none">• The exterior stucco appears to have numerous small cracks on the surface. Recommend sealing and painting with approved material to prevent moisture intrusion into wall cavities.

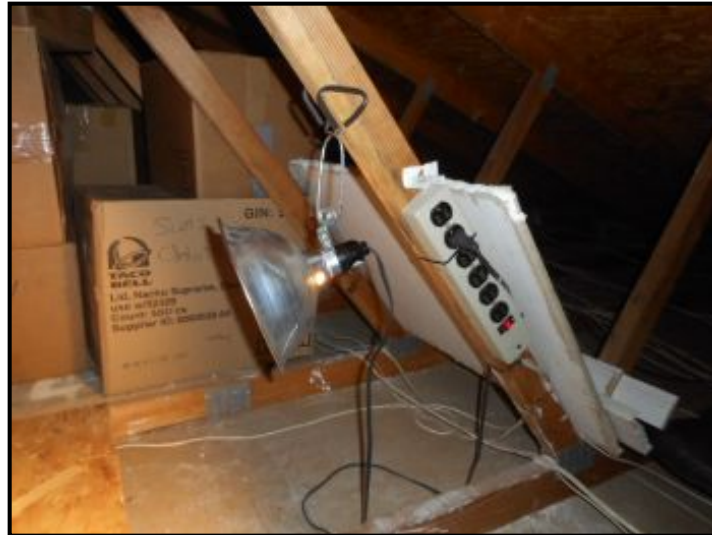
- Most areas not accessible due to insulation.
- **I observed a power strip with a flood light in the garage attic. Recommend removing and installing a permanent switched light fixture if lighting is desired in the garage attic space.**

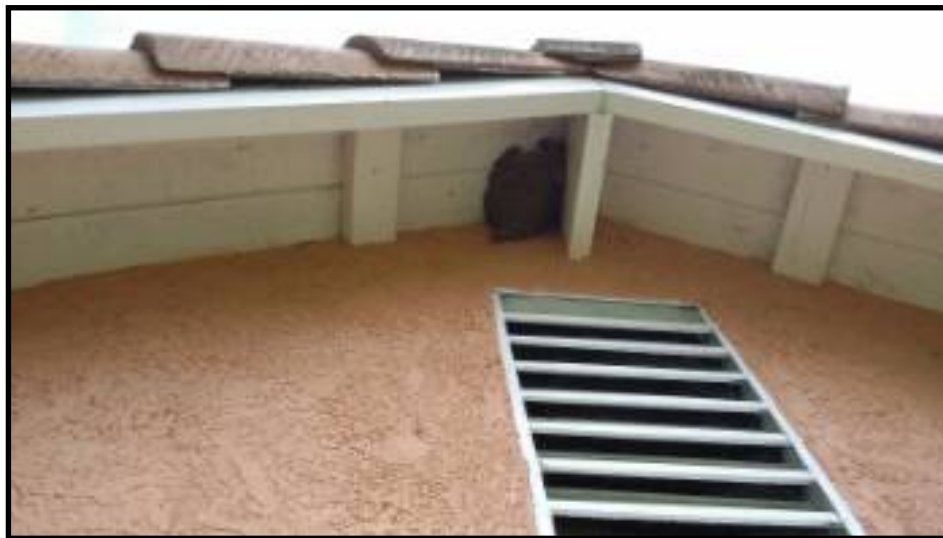
- I observed what appears to be a bird nest made of mud under the west eaves of the house. This can retain moisture against the stucco and well as increase the moisture in eaves, potentially leading to rot and/or decay in the contacted members. Recommend removing nest.

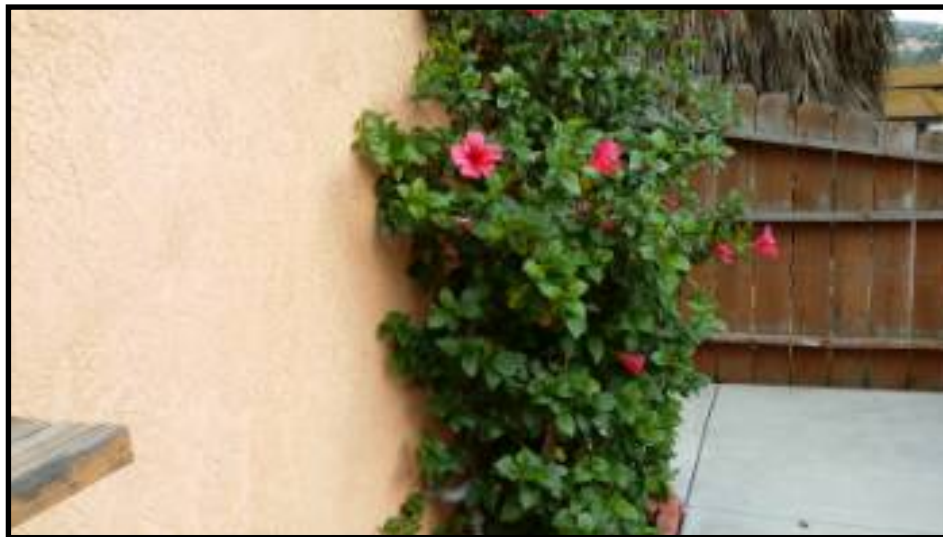
- Prune or remove any plants that are in contact or proximity to home to eliminate pathways of wood destroying insects.

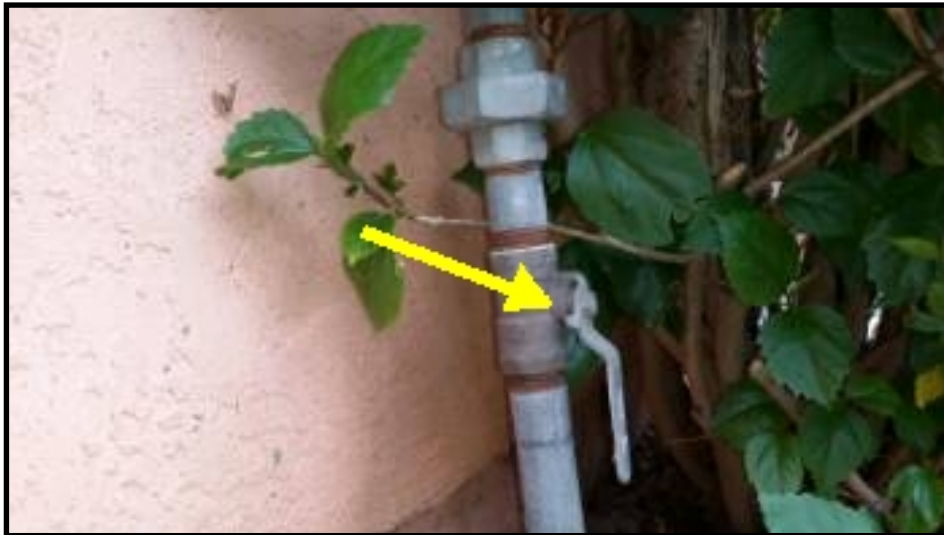
5. Main Gas Valve Condition

Materials: South side.

Gas shutoff.

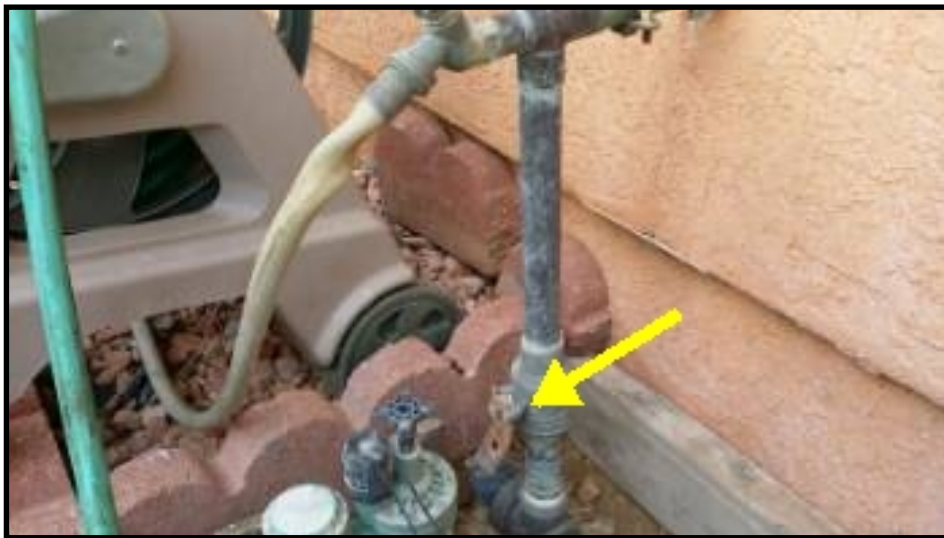
- Main water shutoff on Southside of home.

Water shutoff.

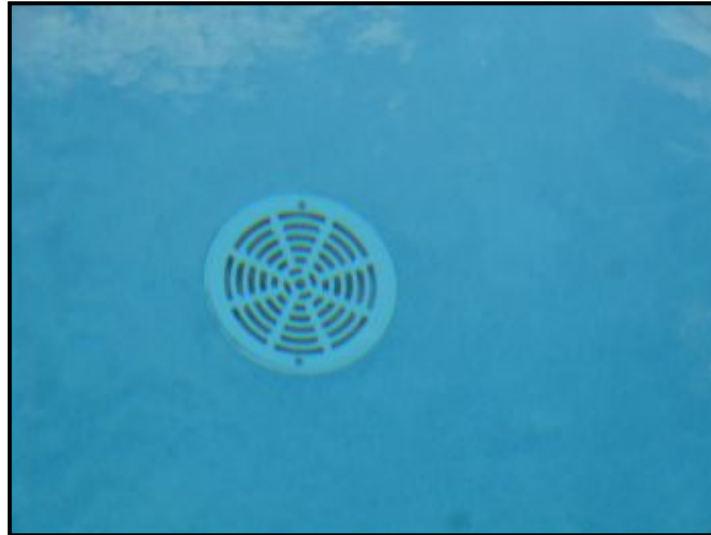
11. Structure Condition

- There did not appear to be an anti-vortex safety cover over the pool drain. This is a potential entrapment and safety concern. Recommend installation of safety cover as needed.

Pool		
Page 31 Item: 11	Structure Condition	<ul style="list-style-type: none">• There did not appear to be an anti-vortex safety cover over the pool drain. This is a potential entrapment and safety concern. Recommend installation of safety cover as needed.
